# **Welsh Ambulance Service NHS Trust**

## **Unannounced Cleanliness Spot Check**

**Date of visit 27 & 28 March 2012**

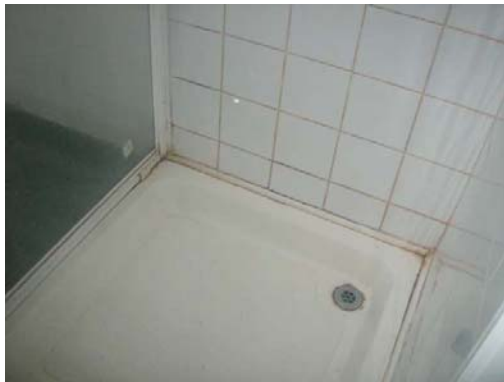
2.1 The fabric of the building was found to be old and tired and the standard of cleanliness was considered to be **poor**.

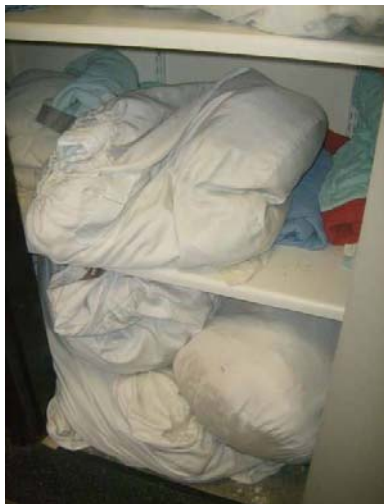
2.5 The station had a designated cupboard for storing clean linen, however the shelving was found to be marked and stained. Staff should ensure that clean linen is stored in a clean area free from stains.

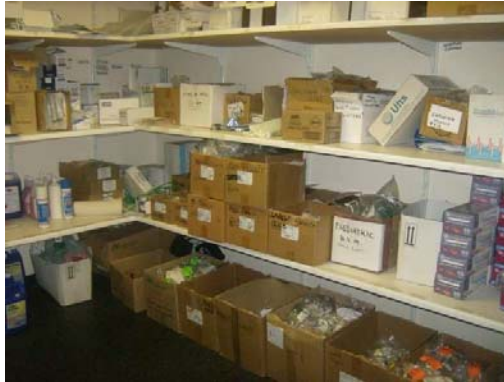
2.8 In the storage room a number of boxes were being stored on the floor making it difficult to clean. All boxes should be stored above floor level to ensure effective cleaning can be carried out.

2.9 The storage room storing equipment was also found to be dusty. Staff should ensure that appropriate cleaning is carried out within this area.

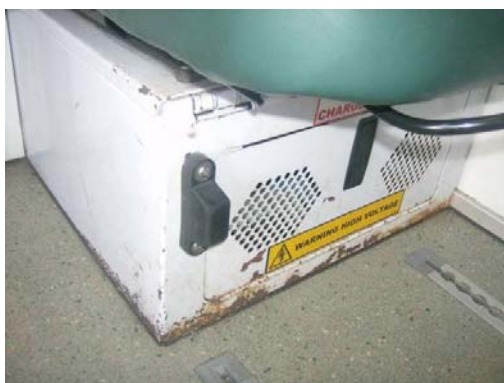
2.11 The stretcher was found to be clean and ready for use. However, other surface areas within the ambulance were found to be dusty and oily. This included suction units and oxygen cylinders.

2.12 The underneath of the chairs in the patient area of the ambulance were found to be rusty and therefore making it difficult to clean.

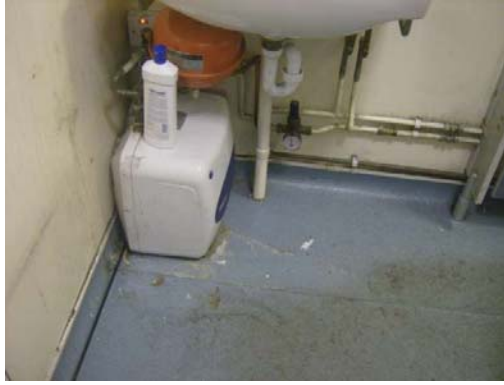
2.19 The general standard of cleanliness was found to be **poor**. The station has not had a domestic cleaner employed for some time and the impact of this was evident

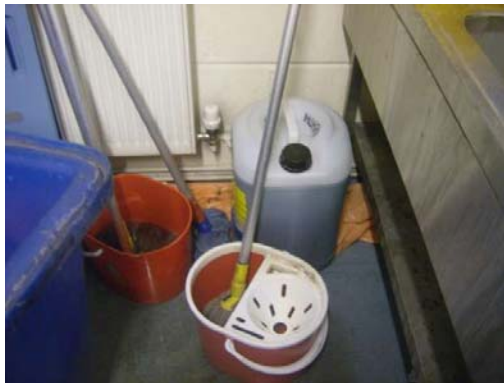
2.21 The dirty utility was in a poor condition and cluttered with a number of items being stored by the sink and on the work surfaces.

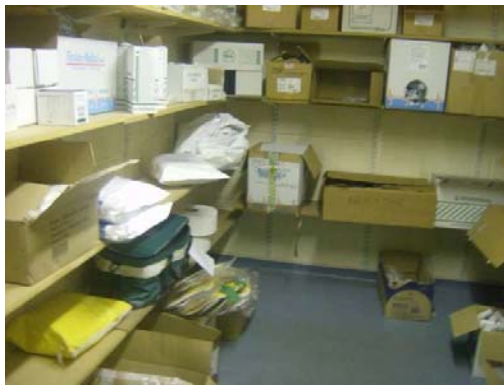
2.26 The storage room was found to be cluttered with a number of boxes being stored on the floor and therefore making it difficult to clean. All boxes should be stored above floor level to ensure effective cleaning can be carried out.

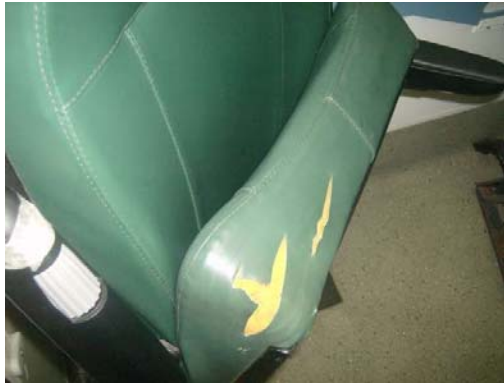
2.29 The stretchers were found to be clean and ready for use. However, other surface areas within both of the vehicles were found to be dusty and oily. This included suction units and oxygen cylinders.

2.30 The chairs in the patient area of both of the vehicles were found to be torn, allowing fluids, dirt and bacteria to penetrate the material. These should be re-covered or replaced with an impermeable material so that they can be clean appropriately.

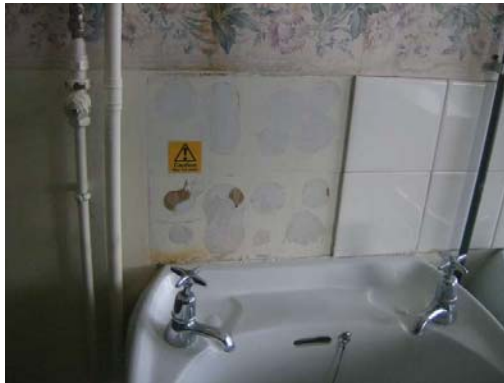
2.36 The standard of cleanliness was generally found to be acceptable.

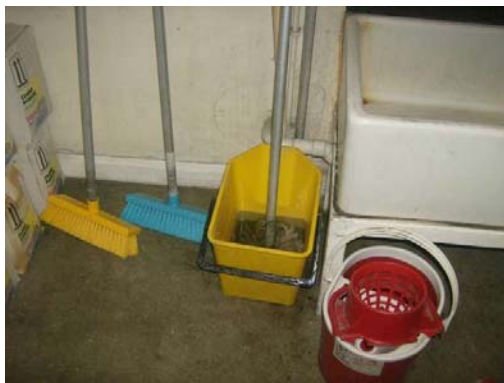
2.37 Staff changing and toilet facilities were in a poor condition.

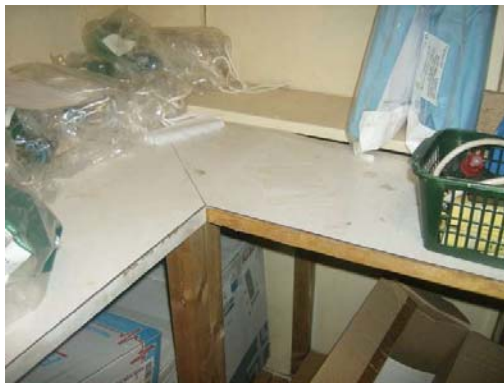
2.43 There were designated cupboards and rooms for storing equipment. However the shelving was found to be dusty and badly damaged. Staff should ensure that cleaning is carried out to an acceptable standard.

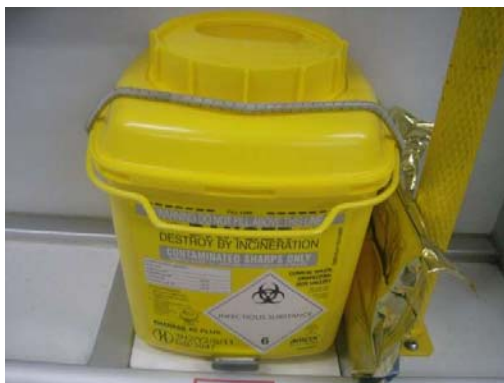
2.50 Within all of the vehicles the sharps boxes were undated or unsigned. Staff should ensure that all sharps containers are correctly labelled.
