Spire Cardiff Hospital

Unannounced Cleanliness Spot Check

Date of visit 13 January 2011

Healthcare Inspectorate Wales

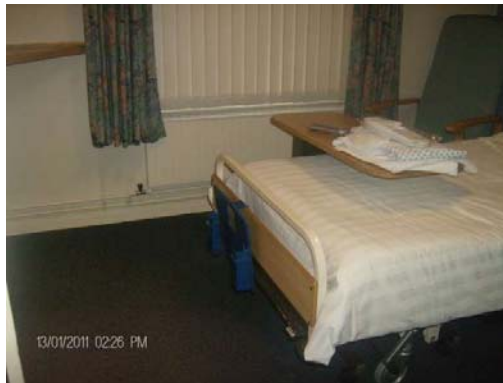
- A number of patient rooms are carpeted and this is not conducive to effective cleaning as they can harbour bacteria and organisms.

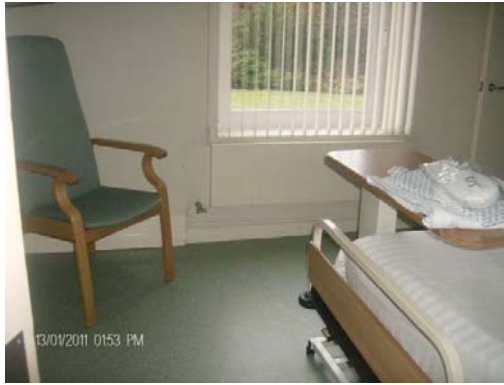
- The refurbished patient rooms had appropriate flooring that can be easily cleaned.

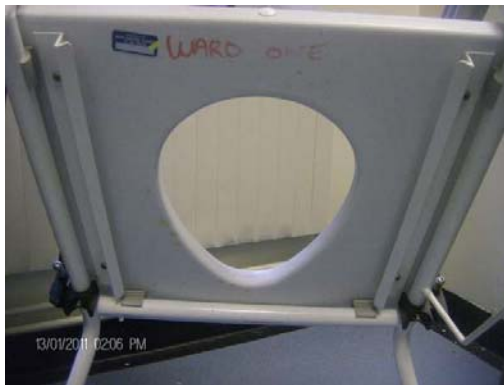
- On examination we found that a commode had not been cleaned to an acceptable standard. A consistent approach to the cleaning of commodes should be in place.

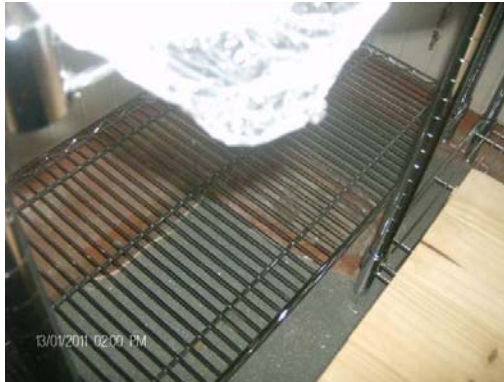
- The ward complied with national standards in relation to handling and disposal of linen, however within the linen room an area of the floor had bare concrete, this is not conducive to effective cleaning and suitable flooring should be in place.

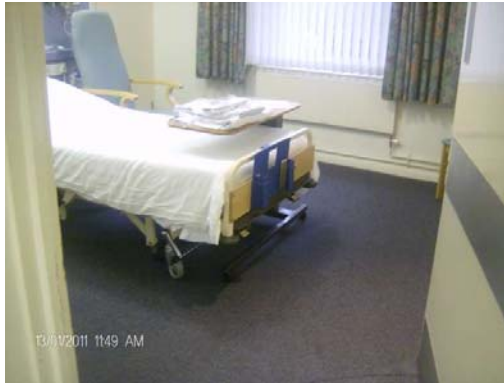
- A number of the patient rooms were found to be carpeted and this is not conducive to effective cleaning and the refurbishment programme will address this issue.

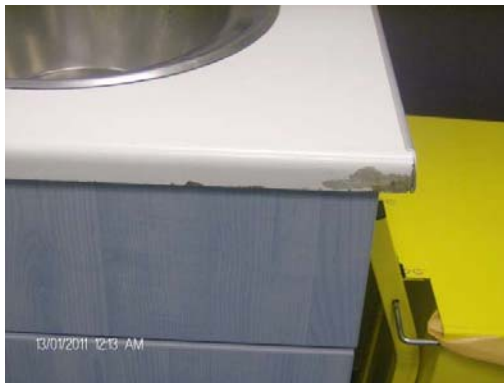
- The worktop in the dirty utility was found to be damaged and should be replaced.

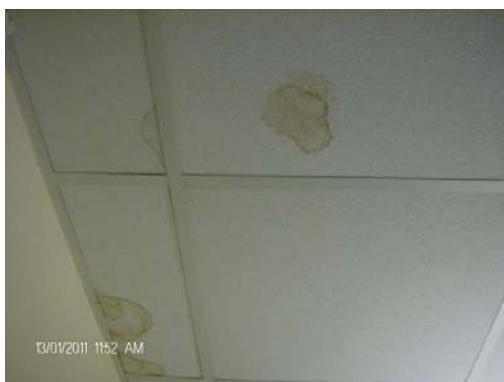
- Ceiling tiles within patient rooms were found to be badly stained and should be replaced.

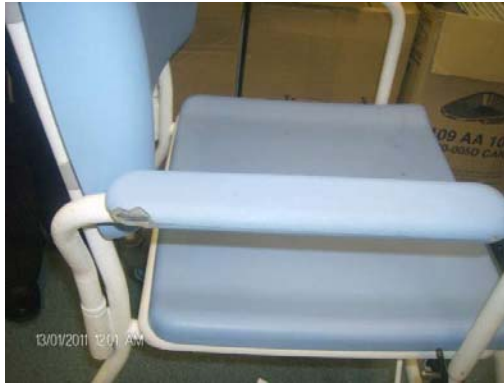
- The commodes on the ward were found to be in a poor state of repair allowing fluids, dirt and bacteria to penetrate the material. These should be recovered or replaced.

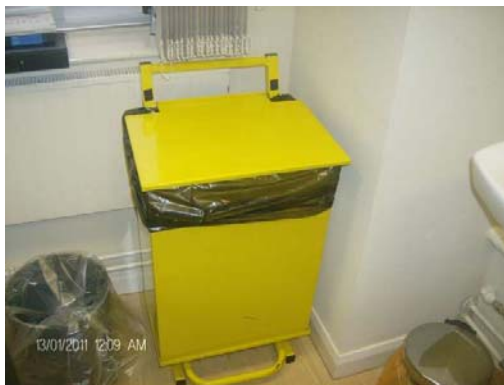
- We found a bin designated for clinical waste to be lined with a domestic waste bag. All bins should be labelled as to what waste should be put in them.

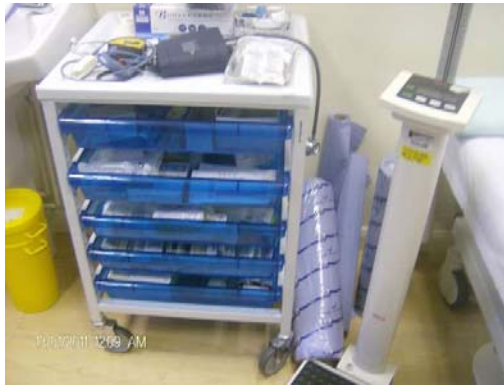
- The storage rack in the pre assessment room was also found to be dusty.
